TOWN OF MEDFIELD

Municipal Facilities

Evaluation and Capital Plan

October 6, 2017

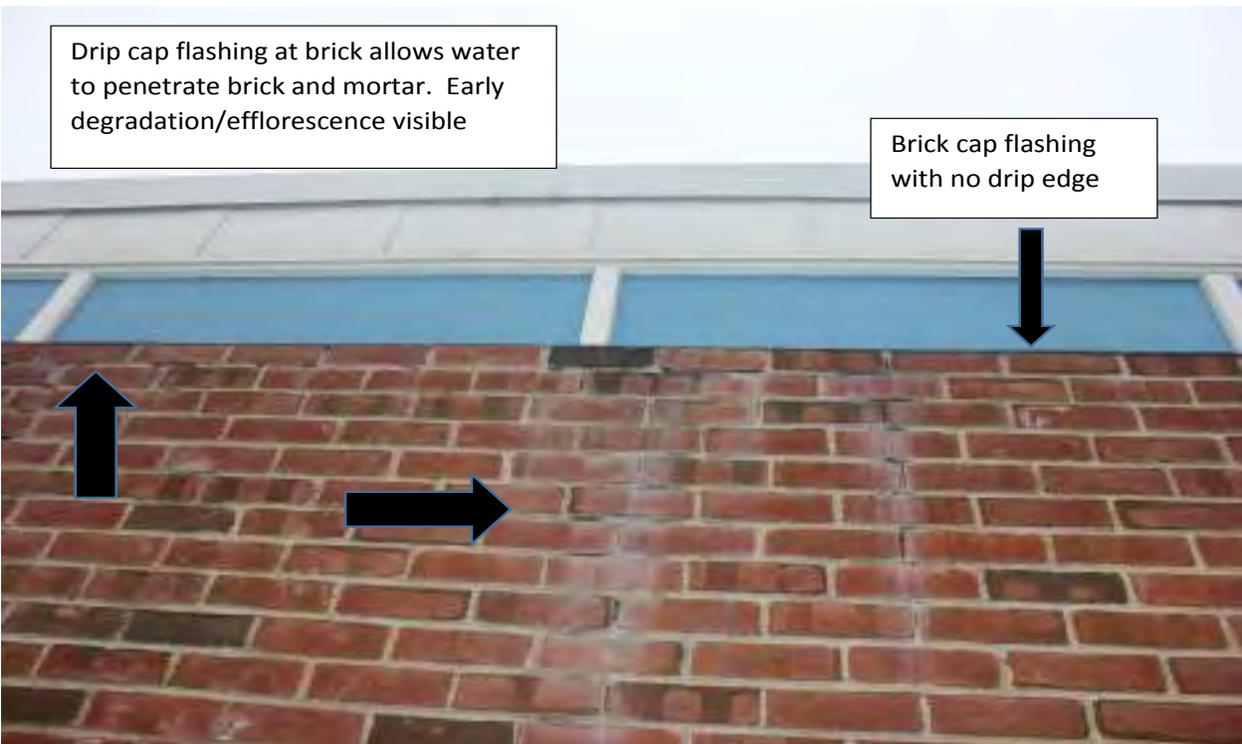
No cap flashing moisture issue

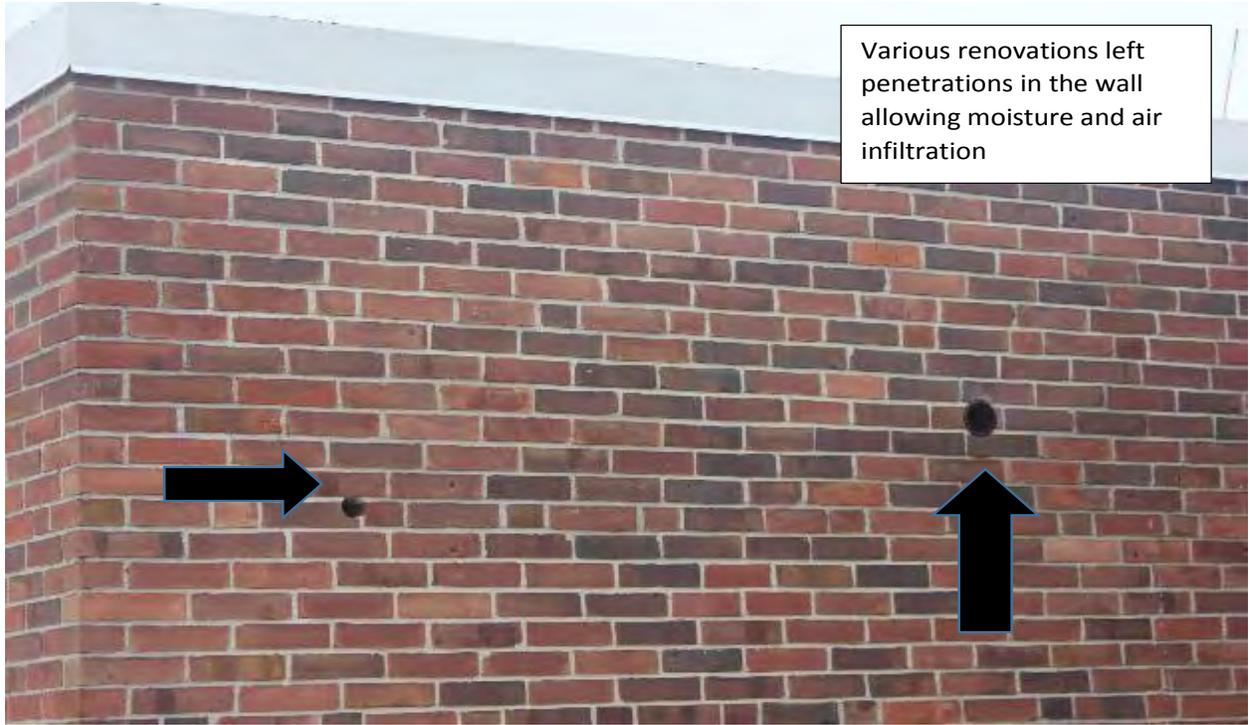
Various renovations left penetrations in the wall allowing moisture and air infiltration

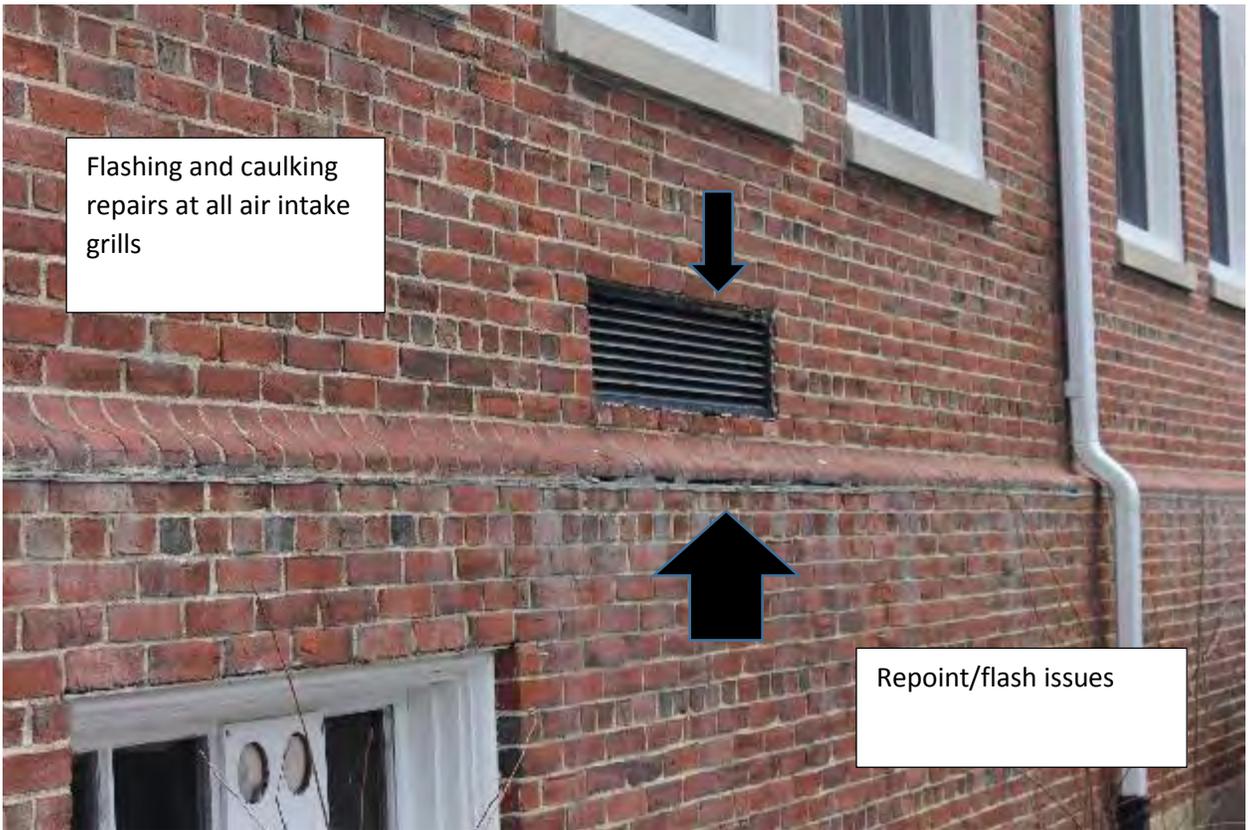
Flashing and caulking
repairs at all air intake
grills

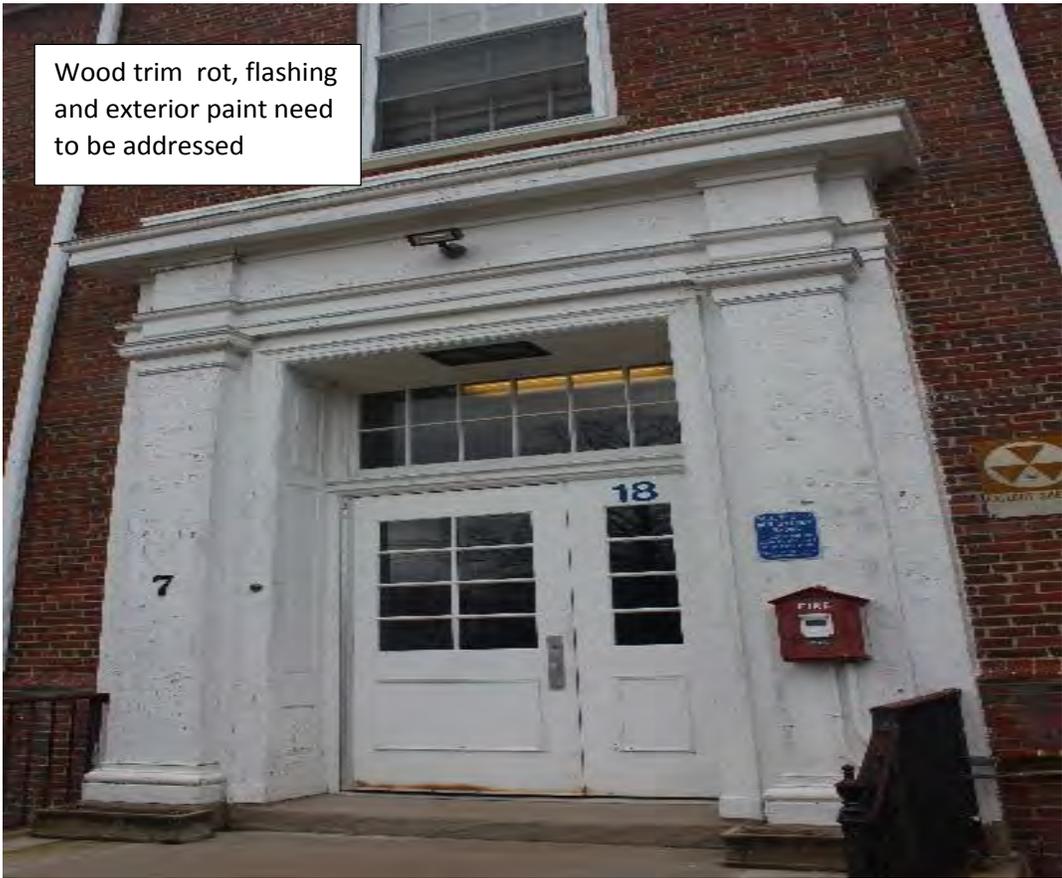
Wood trim rot, flashing and exterior paint need to be addressed

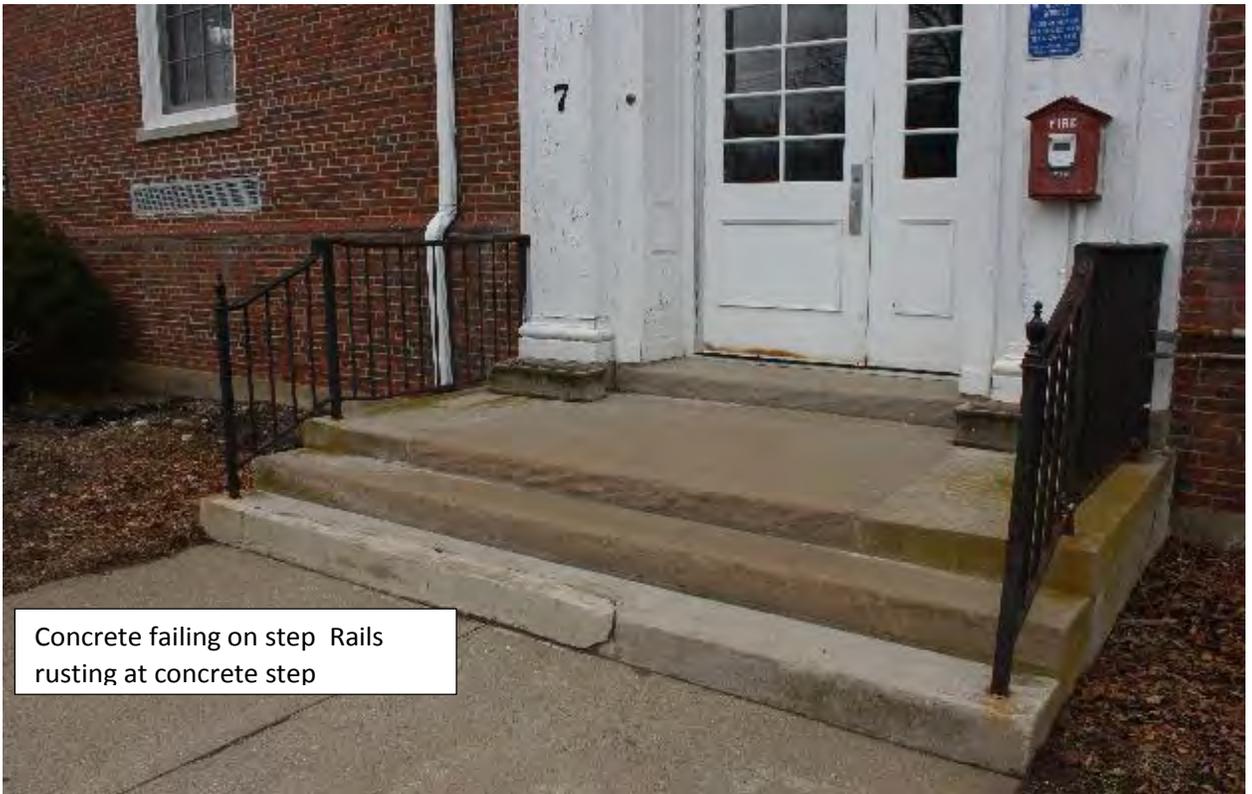
Concrete failing on step Rails rusting at concrete step

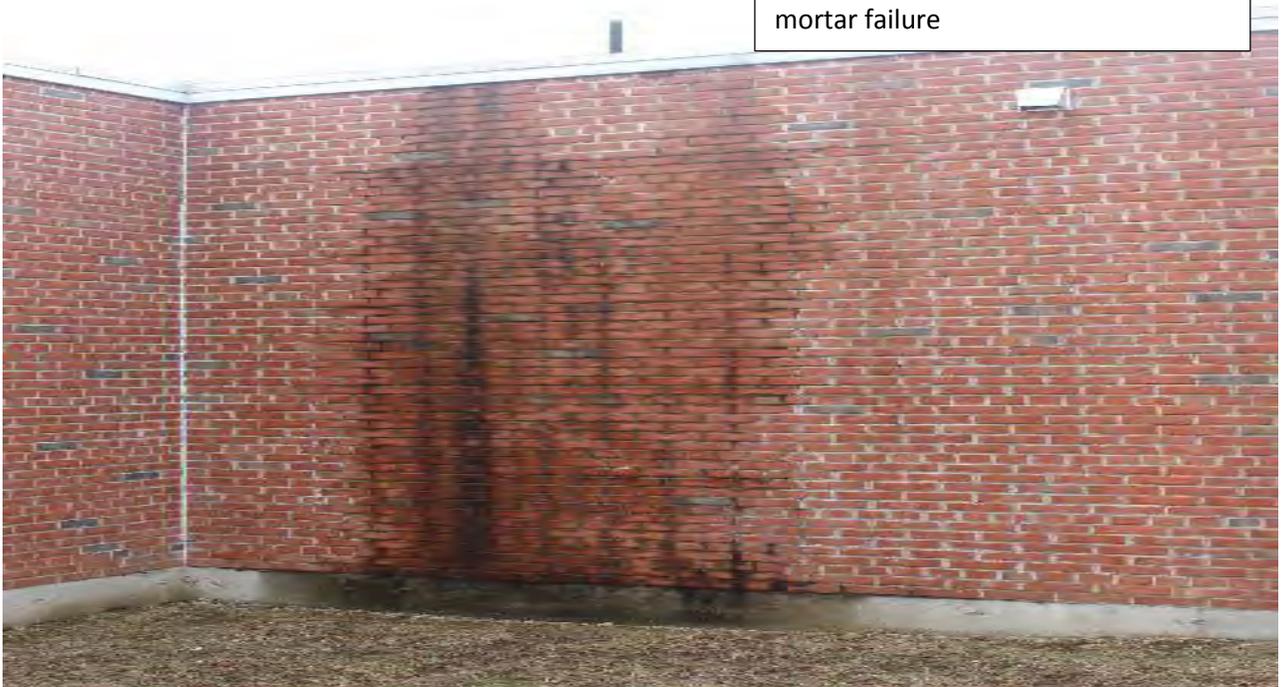
Gutter has deflected due to snow. Leaks in gutter allow water to wash down brick creating excessive moisture
